# Balancing

ISN'T ENOUGH

— Full-spectrum analysis helps isolate complex vibrations

BY MATTHEW DOCK

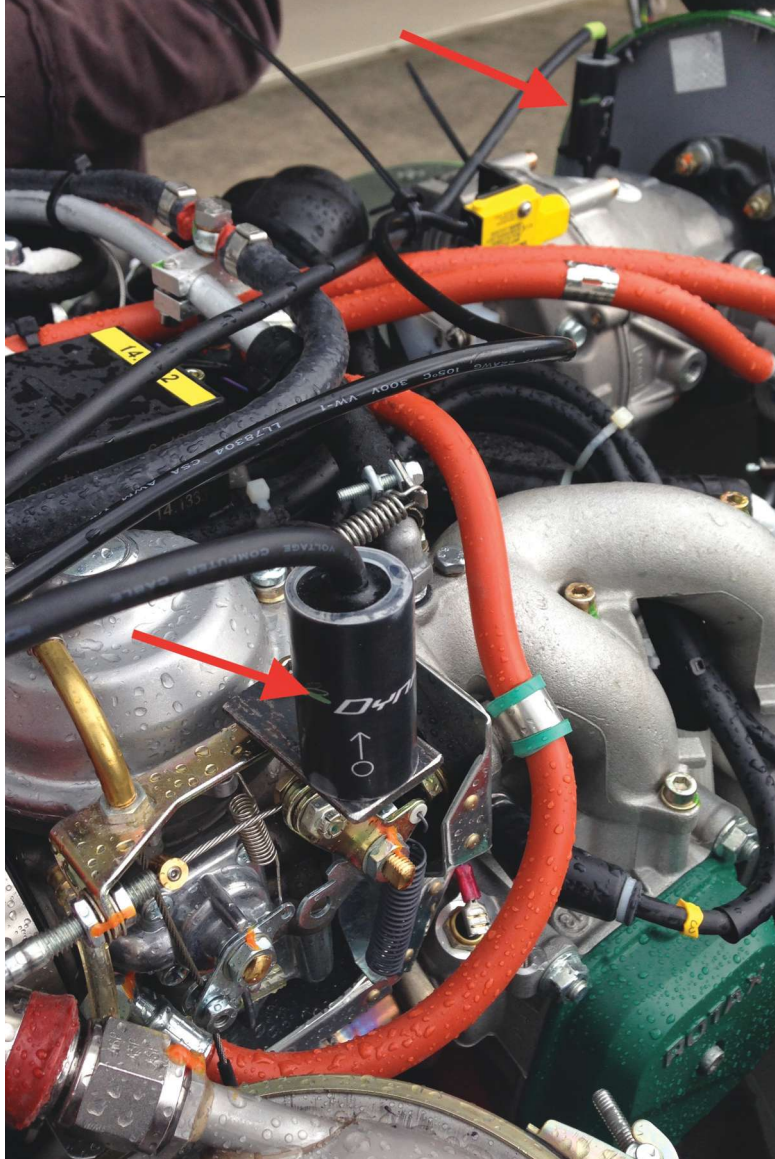
To troubleshoot this complex vibration problem, service personnel conducted a full vibration spectrum analysis using a DynaVibe GX2 from RPX Technologies. The process began with a visual examination of the engine. While it was running in the middle rpm range, gas was seen venting from the carburetors because of the severity of the vibration. Accelerometers were placed on the carburetors to determine the vibration magnitude, and it measured almost 1.5 inches per second (IPS). The right carburetor vibration was almost twice as severe as the left carburetor, perhaps due to its more forward position. To isolate the source of this vibration, the two accelerometers were repositioned to measure the vibration frequencies: one was mounted on the right carburetor, the location of the observed vibration, and a second was mounted above the crankshaft near the front of the engine, to measure propeller vibration. Readings were taken from both accelerometers. In the photo, the orange arrows point out where the accelerometers were mounted.

This mounting location was near the edge of the engine, at an ideal location to detect torsional vibration. With the accelerometers in place, data was collected while the engine was running and exhibiting the vibration.
